# Manhole Inspection Summary

Manhole # **S11MM1022MH**

Insp Date: **11/14/08 2:12 PM**

**Location** Address: **SIDE 4652 PIMLICO RD**

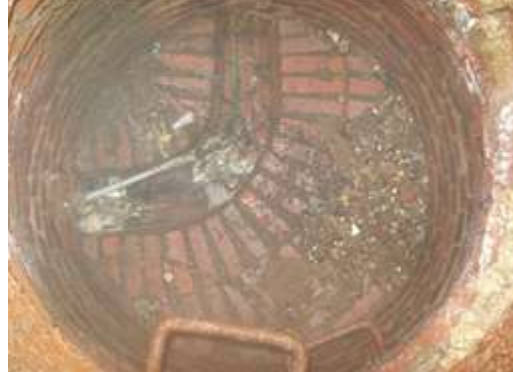
Top View

Condition: **Cracked**

COVER CRACKED

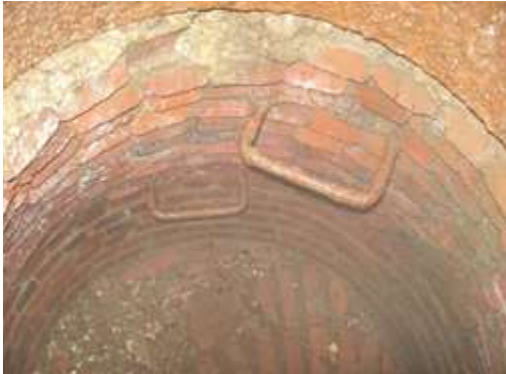
Defect 1

**Steps** Count: **2** Missing: **0** ☒ **Corroded**

CORRODED STEPS

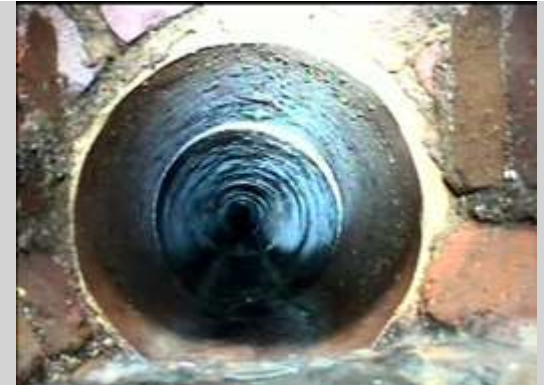
12 O'Clock Outflow

8 in. Circular Gravity Sewer  
Pipe Out @ 12 O'Clock

Infiltration: **None** Pipe Seal Cond: **Cracked**

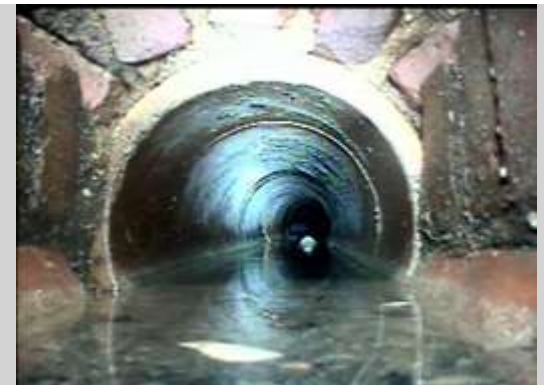
9 O'Clock Inflow

8 in. Circular Gravity Sewer  
Pipe In @ 9 O'Clock

Infiltration: **None** Pipe Seal Cond: **Cracked**
